# A 70 Year Old Shake Roof

A Case Study by Matt Millen

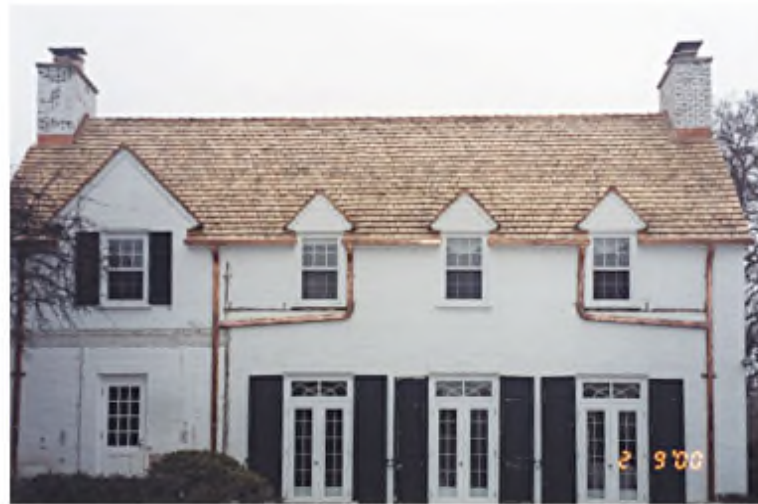
*The Edmund Fitzgerald home featured a 70-year-old roof system.*

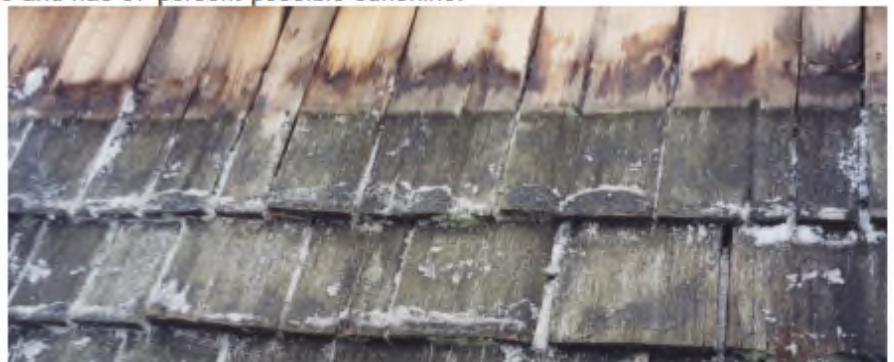
The shingles are western red cedar, with split faces and resawn backs, 24" x 6" (610 x 13 mm) mediums. The 6" (10 mm) butt thickness appears very even with an actual range of 5/8 inch to 1 inch with an average of 5/8 inch in the samples taken. Most widths used run about 5 inches to 8 inches. In the samples the widest is 8.5 inches and the narrowest is 3 inches.

Grains are primarily edge grain. About 50 percent have the rings form an angle of more than 75 degrees with the face. Defects such as flat grain and sapwood, are not present. Today the shingles would be classified as a No. 1 Blue Label Premium Select grade. The shingles appear to have been sorted by thickness to give the roof an even appearance. Some culling of substandard shingles probably was done.

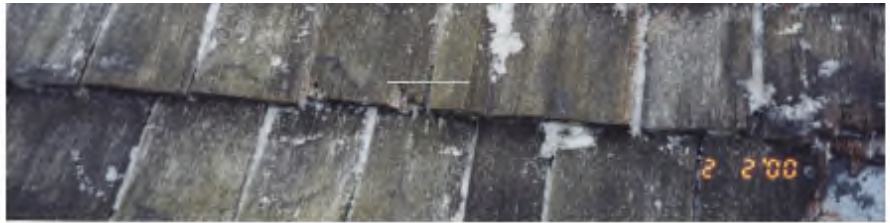
***Original shingles installed on the roof systems north slope.***

The general appearance of these shingles at 70 years is well weathered. On the southern exposure the erosion and splitting of the exposed portion of the shingles is severe. Less than .5 percent were eroded to the point of loss which exposed the interlayment and in some instances the second layer of wood below the interlayment. The most extensive cracking was on the south exposure followed by the west exposure which is typical in the area. Part of one slope where all thinner shingles were used was also more deteriorated except under a 1 \_ inch copper flashing at a windowsill. On the north and east and some west exposures the appearance was not objectionable. In protected areas along sun shaded walls or below copper flashing there was very little erosion or cracking, the shingles were sound and in very good condition. The principle weathering factor on this roof was ultraviolet deterioration and related erosion and water related cracking and leaching of extractives as well as decay. There appears to be more of a relationship between sun exposure and decay than moisture and decay on this roof. East exposure shingles were more decayed than north exposure shingles even where lichens were growing on the cut butt ends.

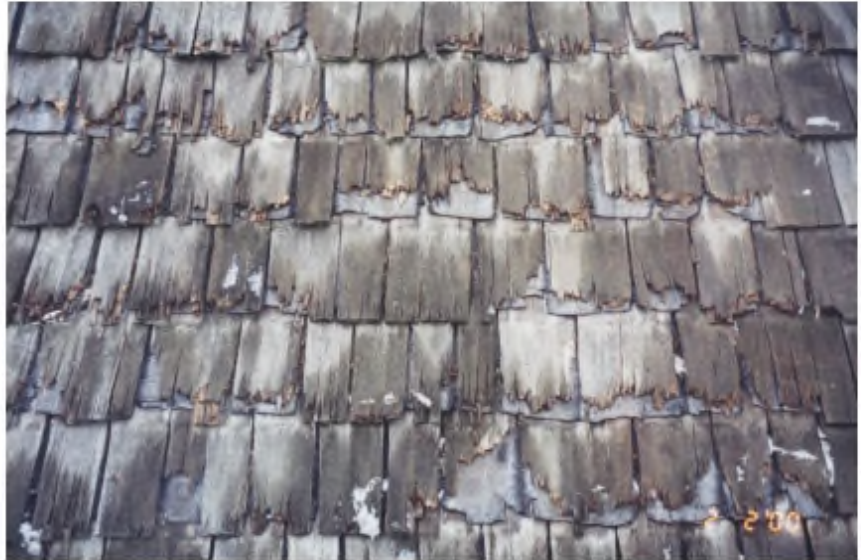
***Original, thinner shingles installed on the roof systems east slope.***

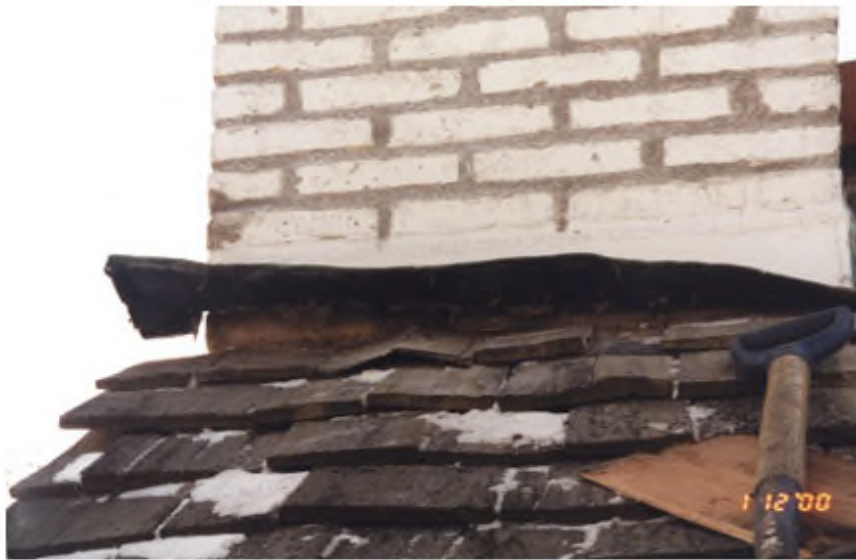
**Apron flashing installed at a chimney on the roof systems north slope.**

At masonry walls and chimneys a 5 inch 16 ounce copper counterflashing is exposed. It covers the step flashing by about 2 inches. The brick was diagonally cut at installation. The 2 to 3 inch top edge of the flashing was installed over the brick and diagonally cut brick were mortared in over the copper edge. There is no water penetration or stains evident. Apron flashings at dormer and chimney head walls are 16 ounce copper. The size is 4 inches over the shingles and 5 inches up the wall. There are some water stains on the roof deck at the chimney apron flashings. At some small dormers there is about 2 inches over the shingles and the remaining, about 4 inches, is set under the wood windowsills or window framing.
