ISSUE 122: DECEMBER 2016

# DIESEL TORQUE

# Muted Mondeo

# Hi H1

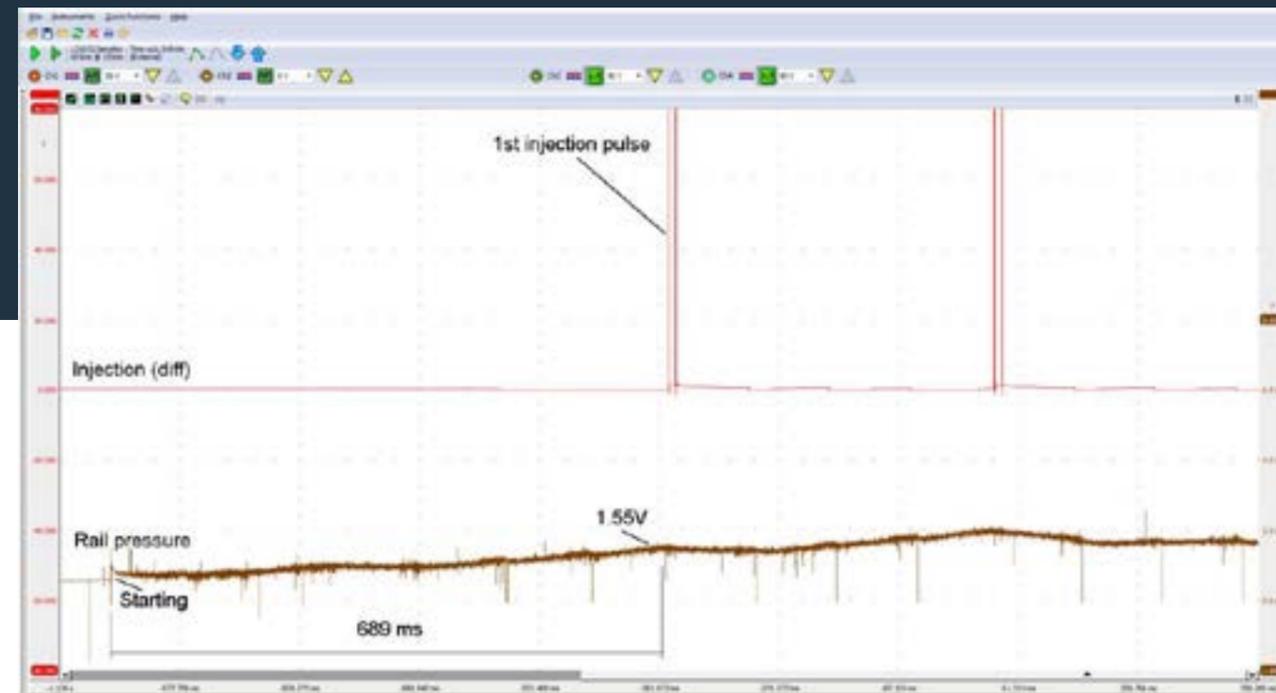
The ATS scope recording looked all normal! After about 2/3rd of a second the rail pressure is high enough to allow injection. Please note that injection does not take place when the rail pressure is not high enough.

Zooming in on the injector pattern at first glance did not reveal anything odd. The injectors are Piezo injectors.

ATS scope recording Injection vs rail pressure.

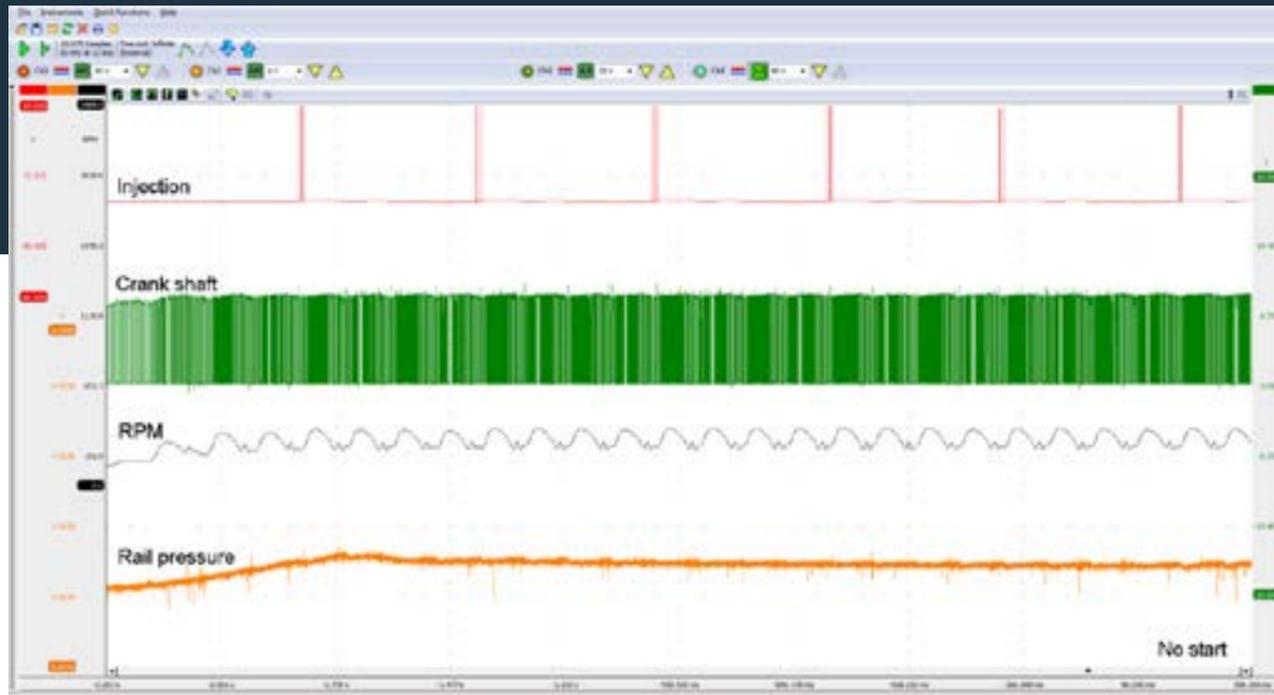
From the recording above it is clearly visible that the injector fires at around TDC (slowest crank speed), which is normal for a common rail low compression engine while turning slow.

ATS 5004 3 channel recording with added RPM trace for TDC detection.

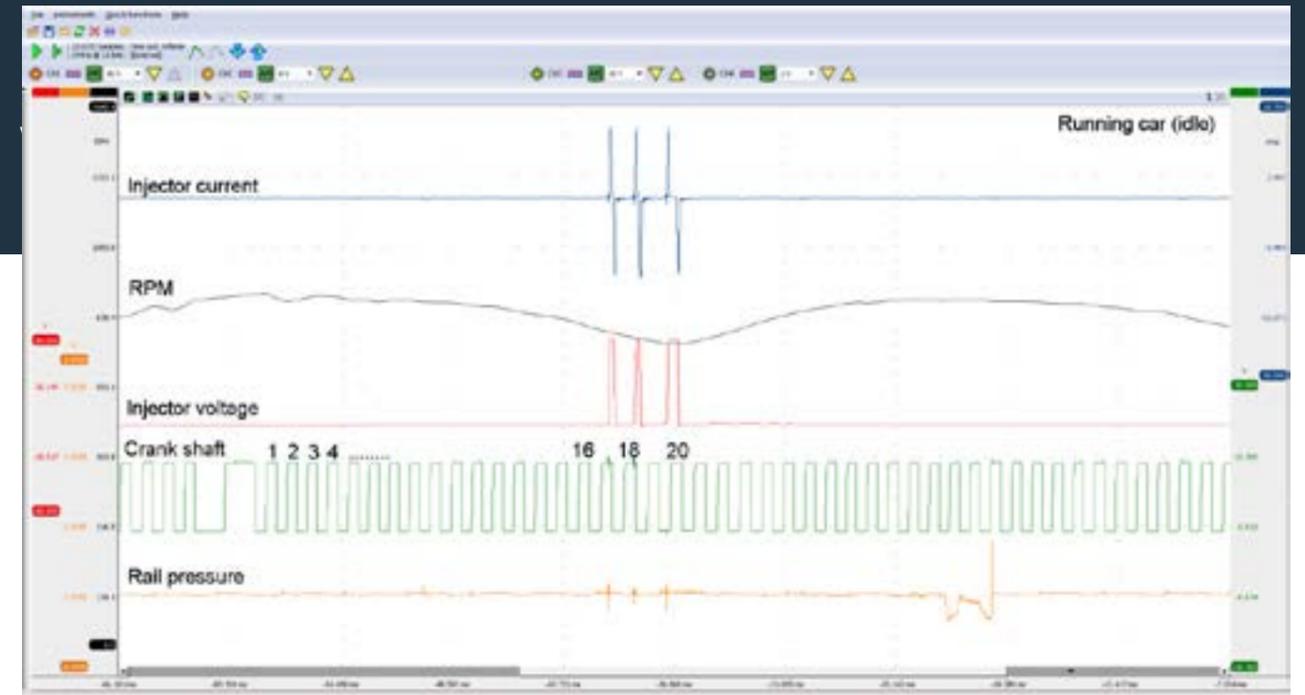
This showed clearly that the injector fired at approximately the same spot on the crank shaft as the non-starting car.

ATS recording for timing check, good car.

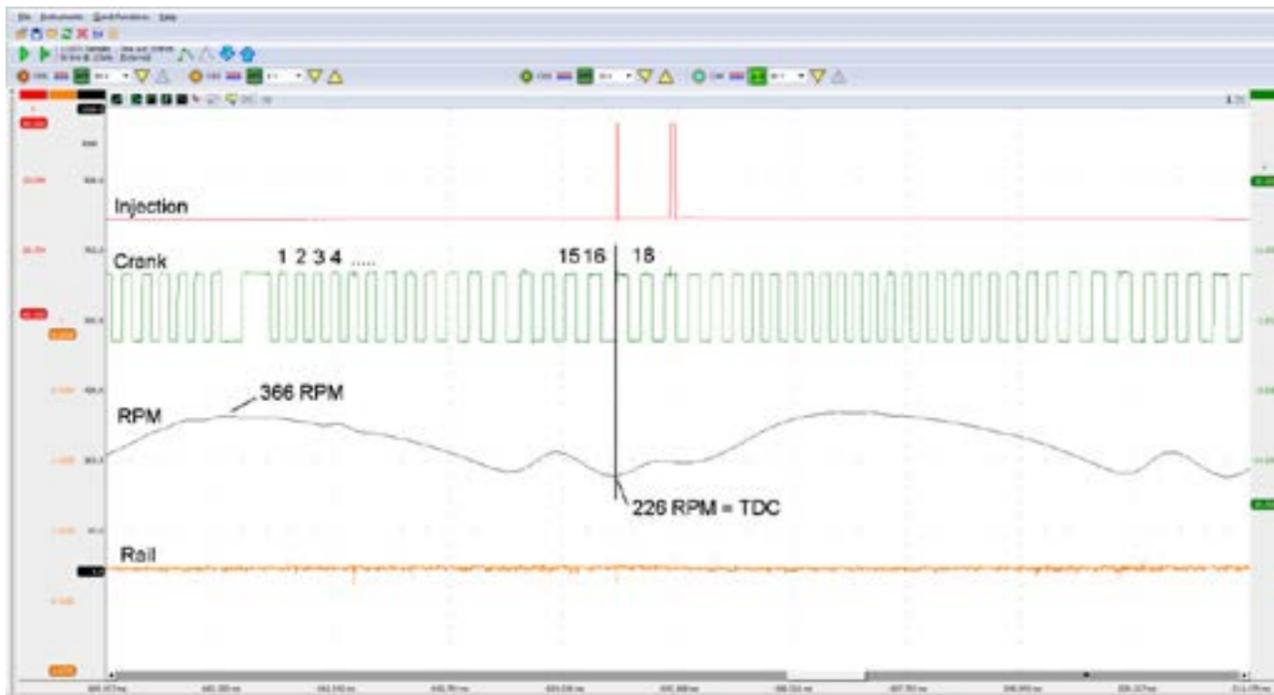
ATS recording zoomed in for timing check, non-start car.

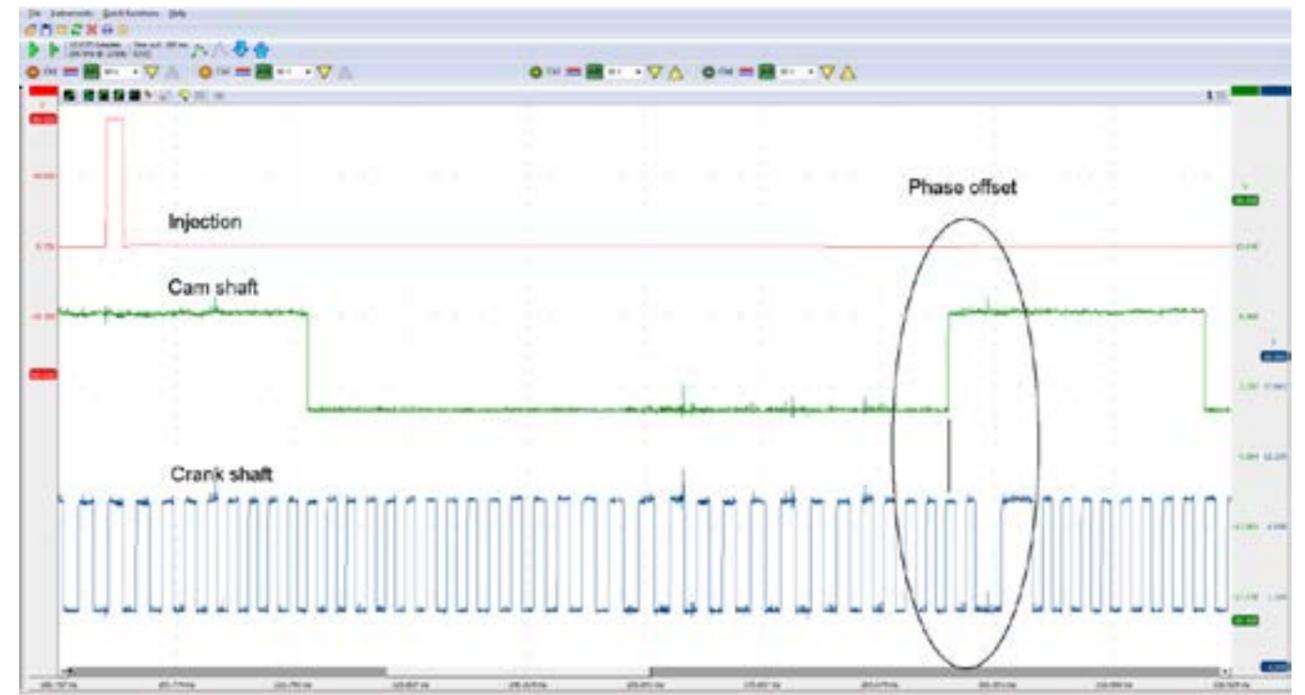
Cam crank relation recording on non-starting vehicle

In the above pattern is the injection pattern visible, yet the engine does not start. Please note the phase offset between the cam and crank.

The timing belt was redone and the car started perfectly (after connecting the injectors correctly back up again).

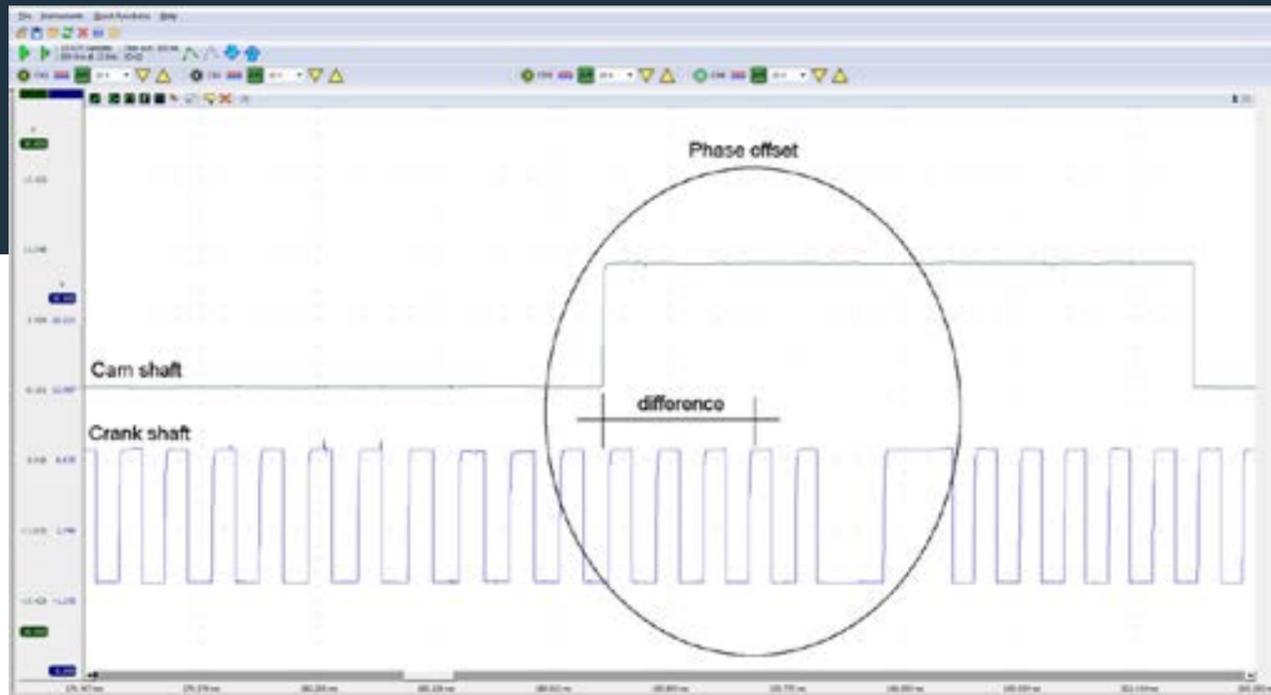
ATS scope recording cam and crank on going vehicle.

The next pattern is recorded on the running identical vehicle. Please note the phase offset between the cam and crank and compare with the not going vehicle.

The phase difference is a bit more than 3 teeth on the tone wheel. On the circumference of the tone wheel are 58 teeth and 2 missing teeth. This makes that from teeth to teeth the crank shaft has rotated 6 degrees. In crank angle degrees is 3 teeth 18 degrees. That is equal to one having the timing belt on the crank shaft sprocket 1 tooth out.

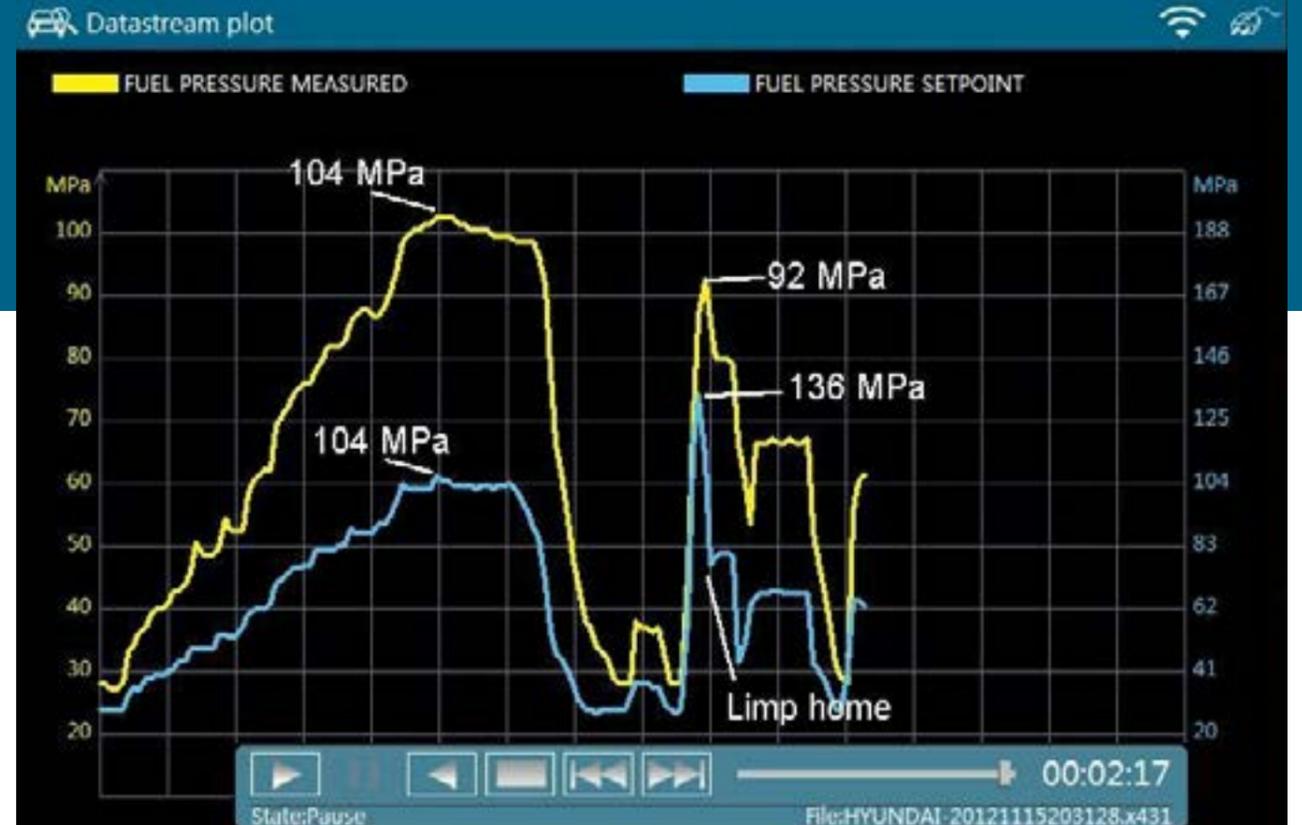
Launch GDS scantool recording of the actual rail pressure (yellow trace) vs desired pressure (blue trace). Please note the different MPa scales.

The actual pressure kept perfectly following the desired pressure while slowly accelerating to cut off speed and decelerating (first part of the graph).

When full acceleration takes place the desired pressure goes up to 136 MPa but the actual pressure does not rise above 92 MPa when the vehicle falls into limp home, yet the pressure is able to get up higher than 92 MPa.

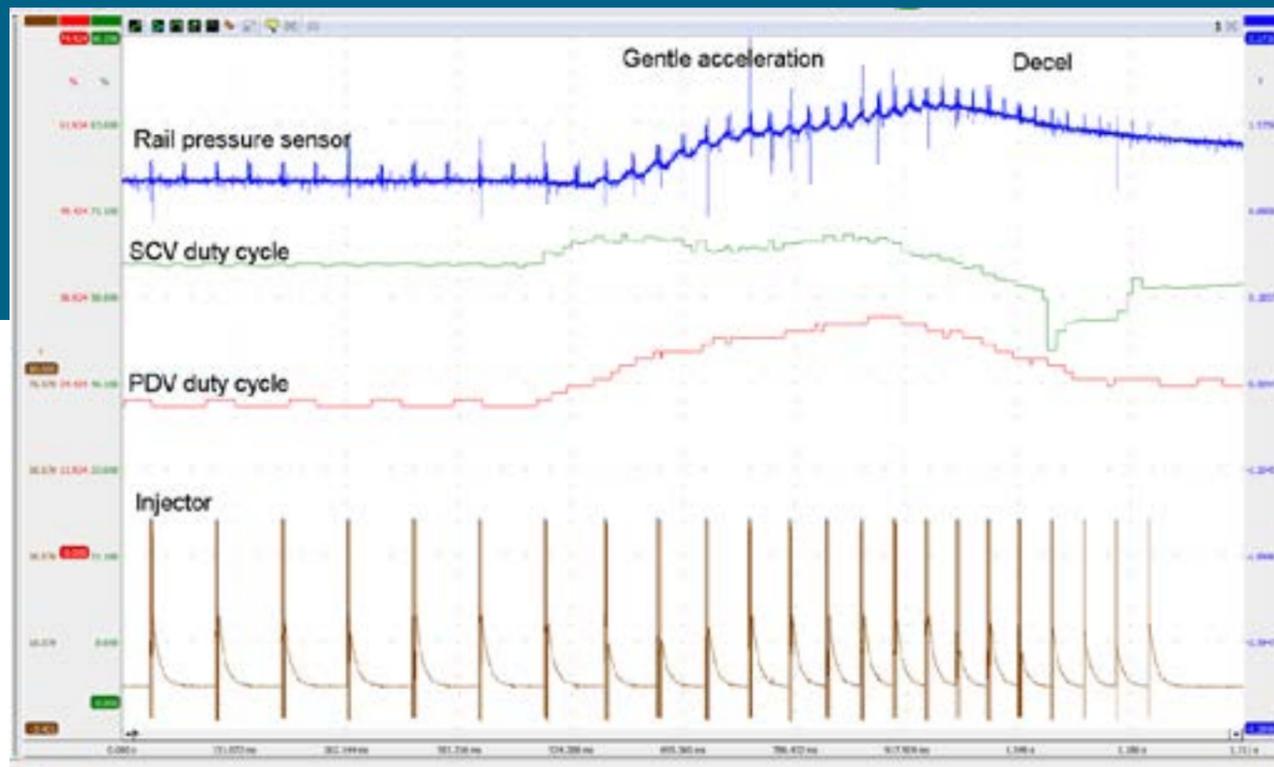
ATS 4 channel scope recording of rail pressure, SCV, PDV and injector.

First we accelerated gently, just like the recording with the scantool. Both the SCV and the PDV traces do not move to ridiculous values, meaning that the ECU has the rail pressure under control, i.e. the actual rail pressure follows the desired rail pressure.

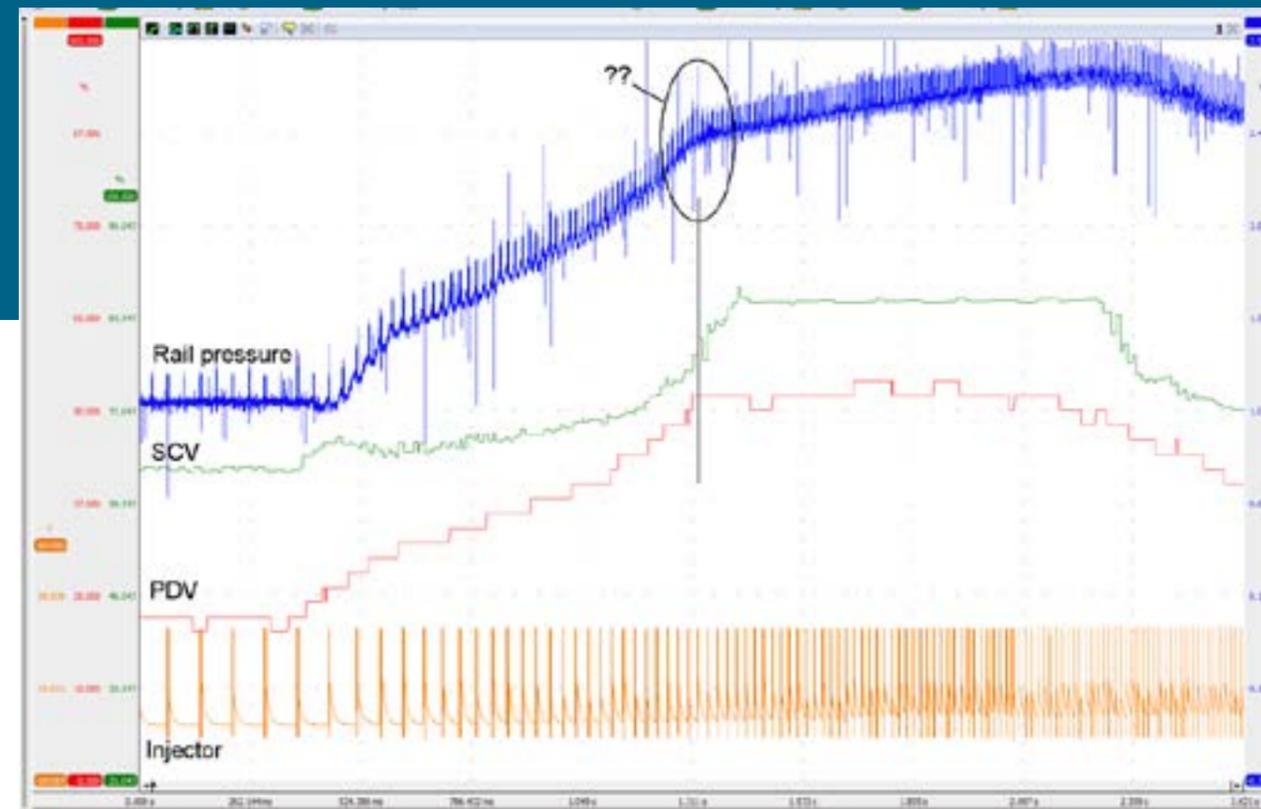
ATS recording during full acceleration, when engine falls into limp home.

A new rail with PDV was ordered and fitted with perfect results.

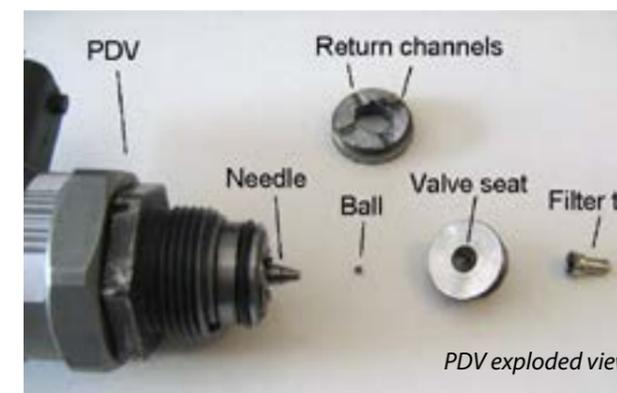
The old PDV was taken apart and some dirt was found in the valve. The ball bearing needs to seal properly when the magnetic field of the solenoid pushes onto the ball. In this case a tiny bit of grit kept the valve open on a small leak, increasing the square surface area of the valve where the hydraulic rail pressure acted upon. An increase in pressure created a strong enough force to open the ball bearing valve in against the electromagnetic force the solenoid valve needle put on the ball bearing.

PDV exploded view.

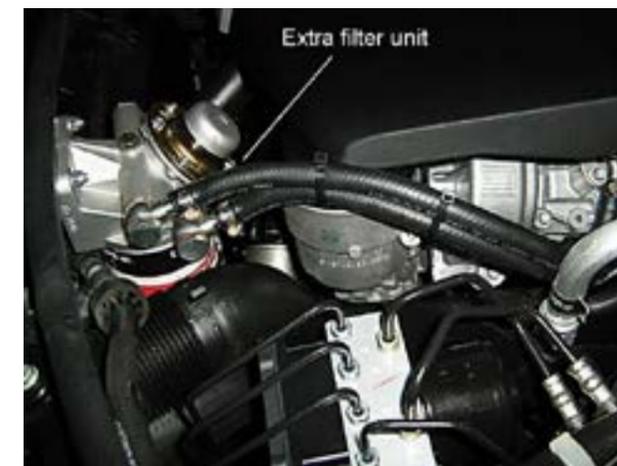
Extra filter unit with glass bowl (bowl not visible).

During our DMS 1-3 common rail Diesel training we advise to fit to any common rail Diesel vehicle (also brand new ones) an extra filter unit with water separation bowl. If water enters the fuel system, the pump, valves and injectors need to be replaced. The genuine filters used on many modern vehicles are not having enough water separation area, plus the water sensor with electrodes protruding into the filter react often too late. It is incredibly expensive to replace the damaged items. It will always end up in a battle with your customer, as water damage to these components is not covered by any warranty and fuel companies do not like to admit that the water came from their fuel station (prove it...).

Use as hoses to and from the extra filter unit SAE 30R9 not SAE 30R7 as I did.
