297 Harrington Circle, Long Lake, MN

Reliable Enterprises Home Inspections

At your request, a visual inspection of the above referenced property was conducted on 6/13/2018. An earnest effort was made on your behalf to discover all visible defects, however, in the event of an oversight, maximum liability must be limited to the fee paid. The following is an opinion report, reflecting the visual conditions of the property at the time of the inspection only. Hidden or concealed defects cannot be included in this report. No warranty is either expressed or implied. This report is not an insurance policy, nor a warranty.

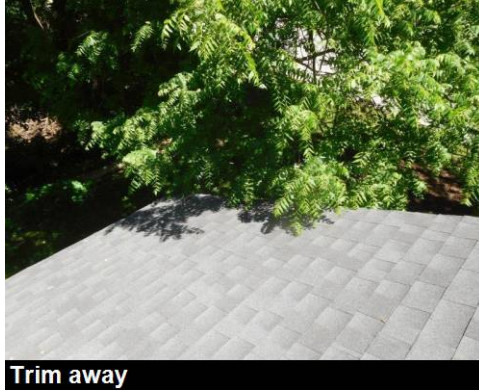
CONDITION: **Trim away branches from structure, branches will rub with wind.**

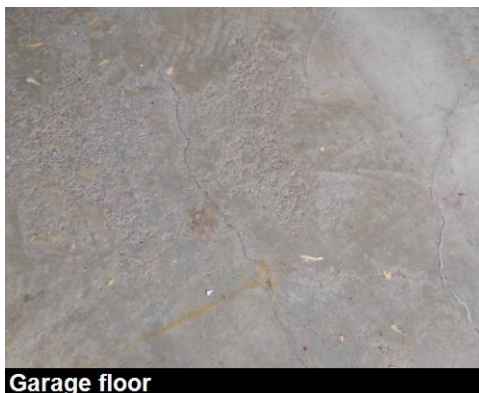
Cracks and salt damage are noted. The garage floor is functional.

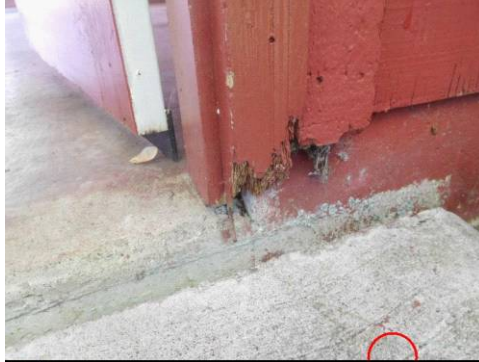
No GFCI type outlets.
Rot on bottom of back door case.
The attic has some insulation and storage.

Rot

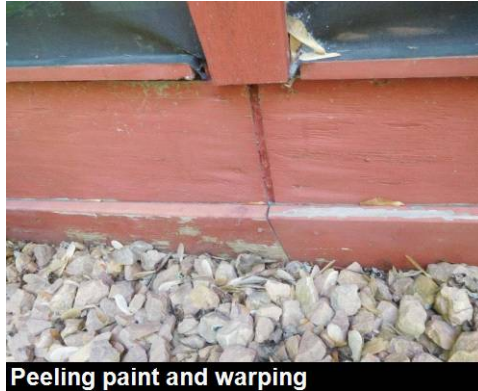
Peeling paint on wood at porch, beginning of warping from moisture.

Peeling paint and warping

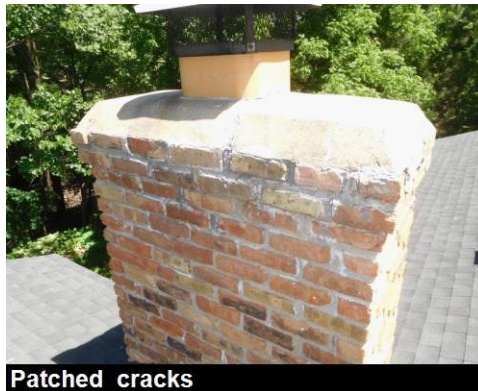
Brick chimney has patched cracks. All cracks should be patched.

Patched cracks

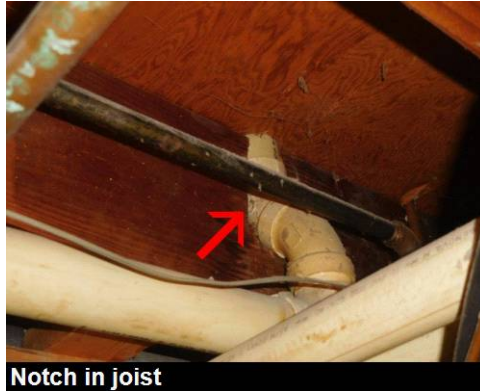
1 joist has been over notched reducing it's integrity.

Notch in joist

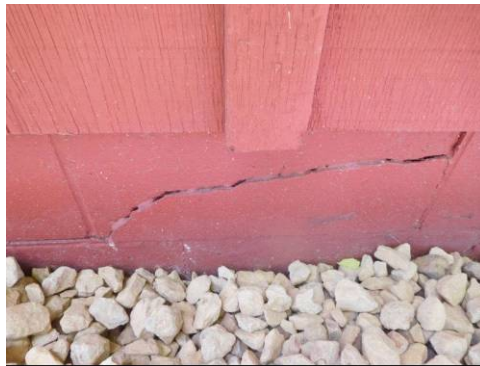
Garage - 1 block is cracked with displacement. There are cracked blocks and mortar. 1 crack in block was patched.

Crack with displacement

All cracks should be patched and monitored.

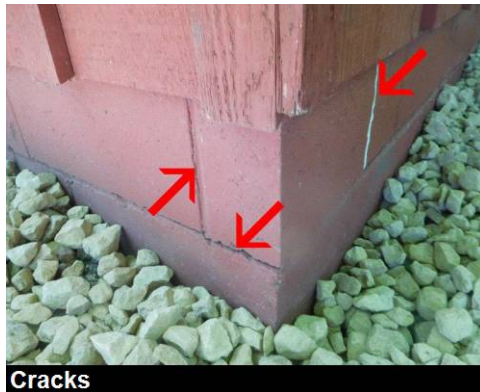
Cracks

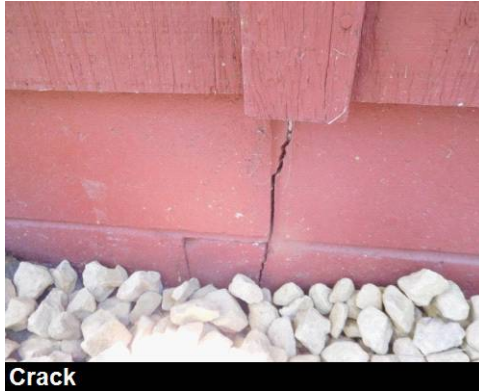
Crack

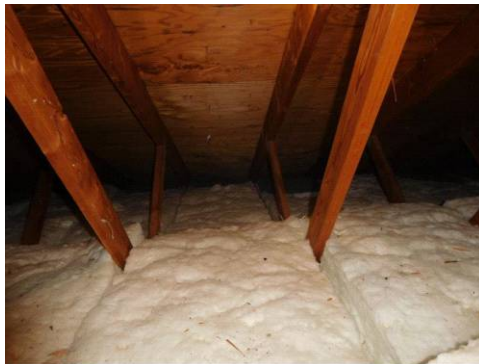
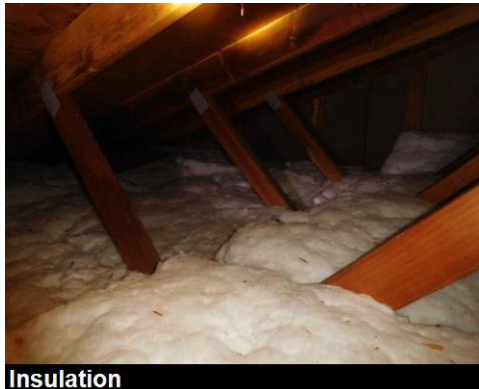
INSULATION TYPE, CONDITION: Fiberglass batts. The insulation is adequate. **Some insulation is uneven.**

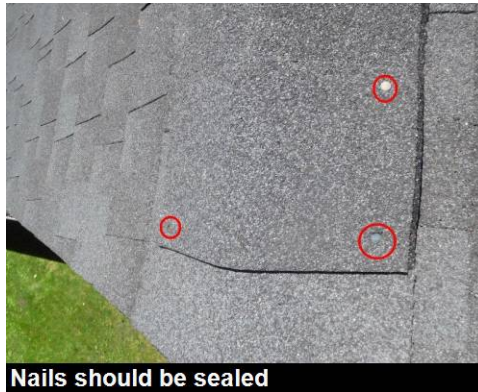
The roof is functional. **Nails showing, should be sealed to prevent leakage.**
4 Years old.

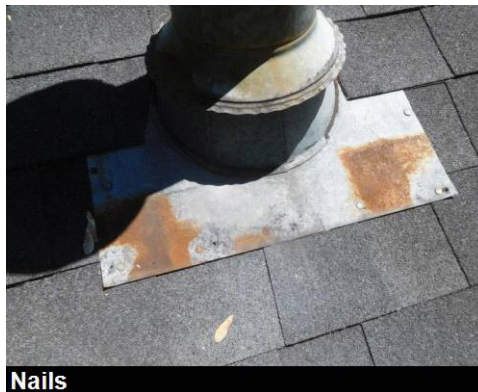
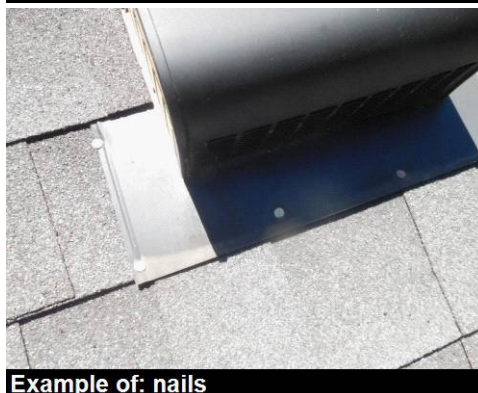
Metal. The exposed flashings are functional.
Nails showing on flashings should be sealed to prevent leakage.
The skylight has a wood frame with peeling paint.

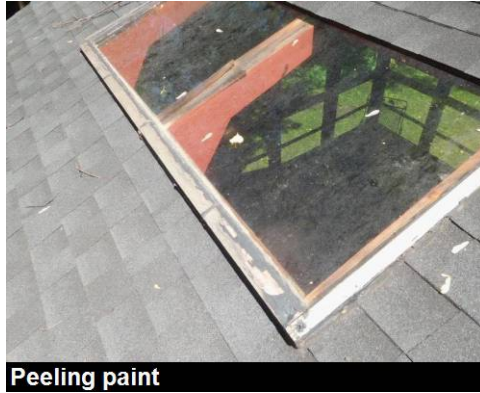
Peeling paint

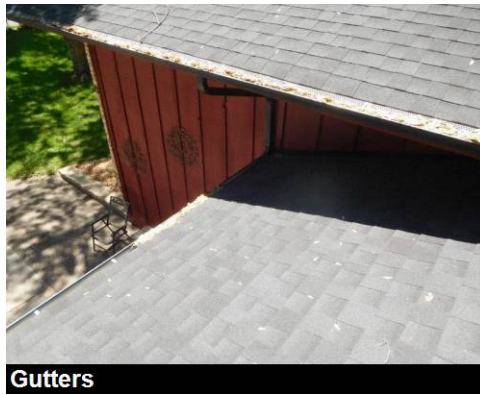
Partial gutters and downspouts. Gutters are equipped with leaf guards in areas. **Debris in gutters, need to be cleaned before functional.**

Gutters

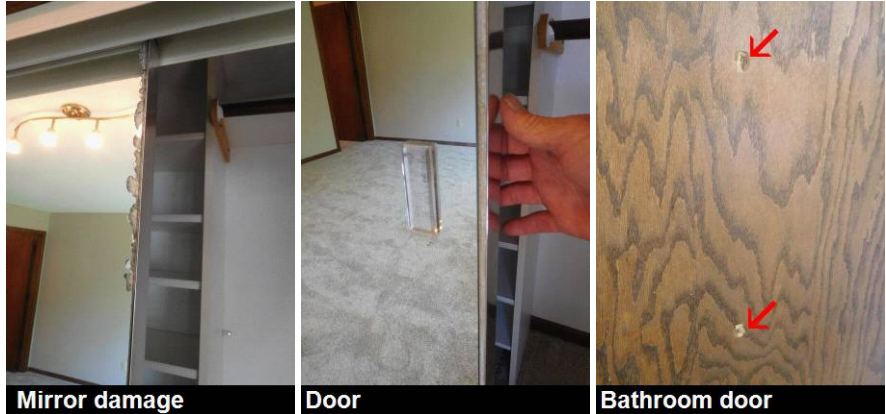
- MAIN ENTRY DOOR:* The main door is operational.
- OTHER EXTERIOR DOORS:* The exterior doors are operational.
- INTERIOR DOORS:* The interior doors are operational.
Damage on downstairs bathroom door.
Mirrored closet doors have damaged mirror and flimsy frame.

Mirror damage

Bathroom door

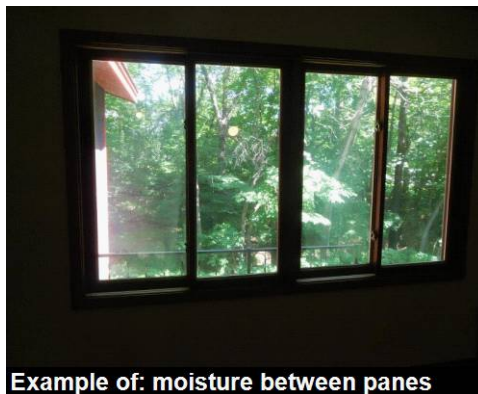
Example of: moisture between panes

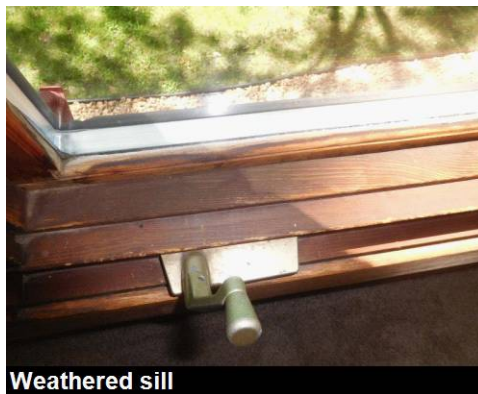
Weathered sill

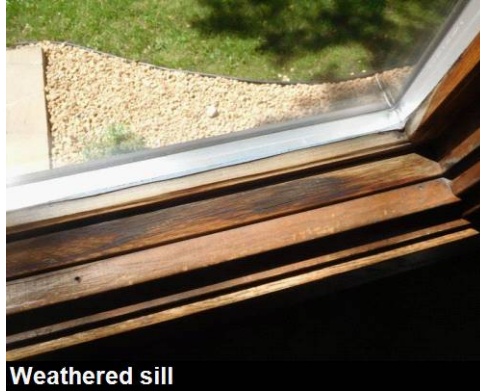
Weathered sill

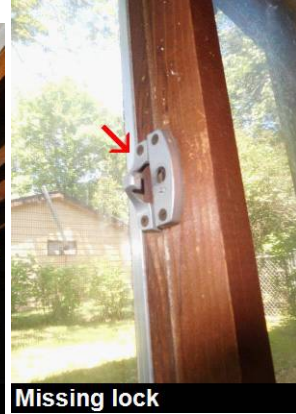
Missing lock

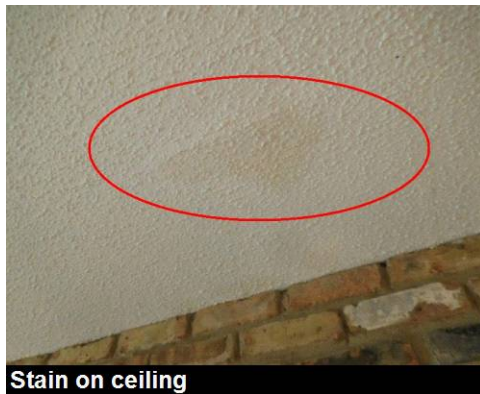
Stains noted by fireplace with a high level of moisture. I think there may be a plumbing pipe for outside spigot in the area, there may be a leak.

Stain on ceiling

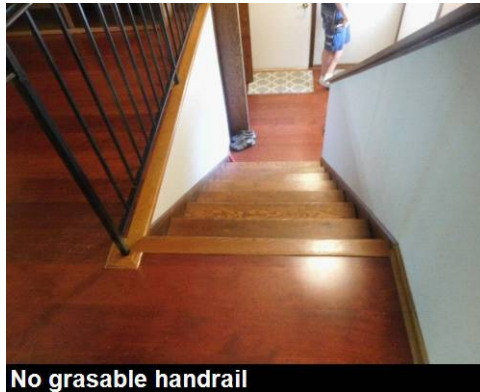
The stairs are functional. **Handrails Missing! Any steps over three risers need a handrail.**

No grasable handrail

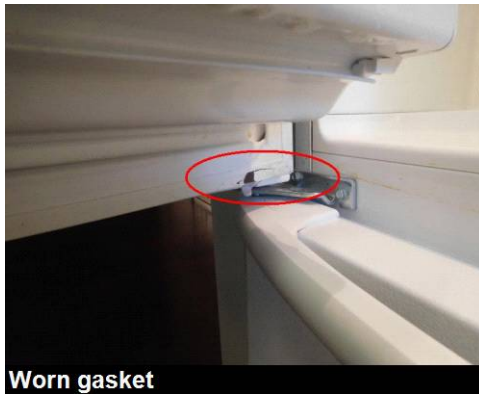
Door gasket is worn.

Worn gasket

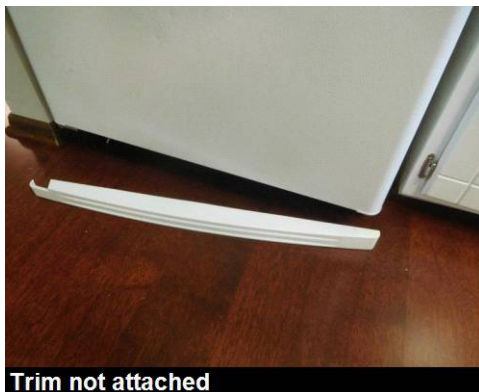
The bottom trim is not attached.

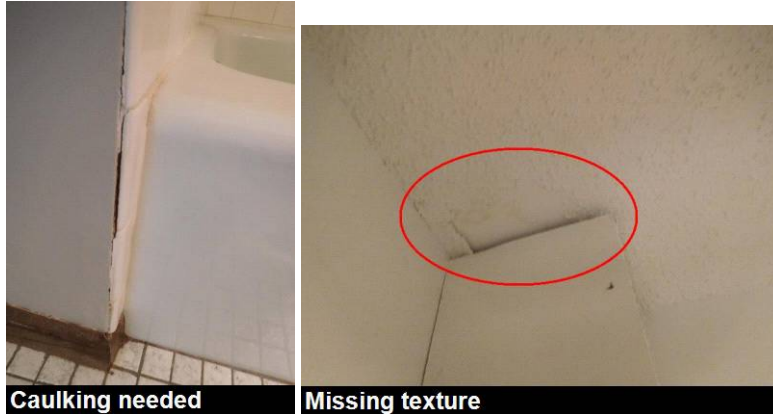
TUB/SHOWER & WALLS: Tub and shower area is functional. **Caulk and seal all tub and shower areas as needed. Loose and missing texture in bathroom closet ceiling.**

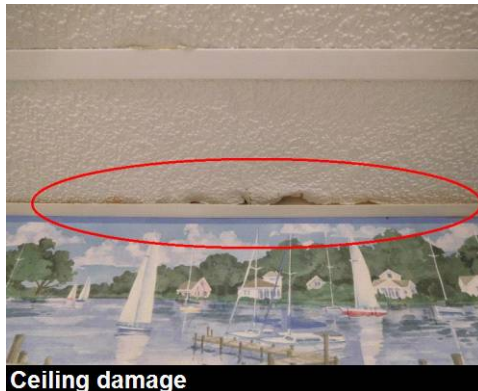
Shower enclosure is functional. **Ceiling damage over shower.**

Ceiling damage

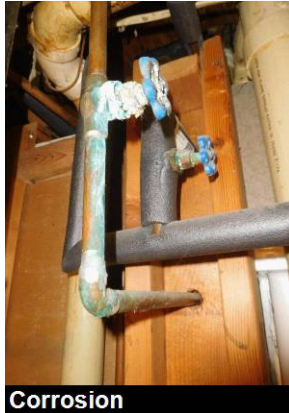
Copper.
The supply lines are functional. **Major corrosion noted.**

Corrosion

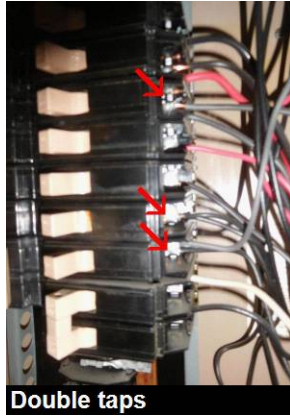
Downstairs. Bedroom. Closet. The electrical panel(s) is functional.
Circuit wire sizing correct so far as visible. Grounding system is present. 200 Amp Service.
4 Double Taps= Two wires are connected to a single lug on a circuit breaker where only one wire should be connected.

Double taps

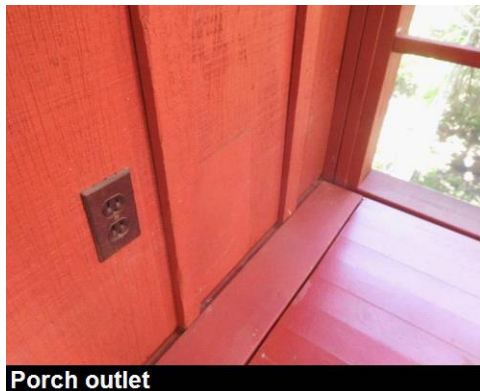
CONDITION: Switches and outlets throughout the house are in functional condition.
The GFCI outlet in downstairs bathroom does not trip, should be replaced.
Ground Fault Circuit Interrupter (GFCI) outlets are suppose to be installed at exterior, garage, bath rooms & kitchen outlets.
Recommended in: kitchen, master bath and garage.
Porch outlet should have a cover and GFCI type.

Porch outlet
