Roof Inspection for:

~ Portland, Oregon 97211

I inspected this roof on March 14<sup>th</sup> 2023. I met the owner. Looked in the attic and got on the roof. The roof is a 1 year old Pabco 'Premier' 30 year factory warranted asphalt laminated shingle in the black color. One layer over OSB over spaced sheathing. Roofer is licensed in Oregon with 'nonexempt' status. Separate photo emails will be sent. Each photo email will be numbered to correspond to the numbered items on the summary report. The following items should be noted:

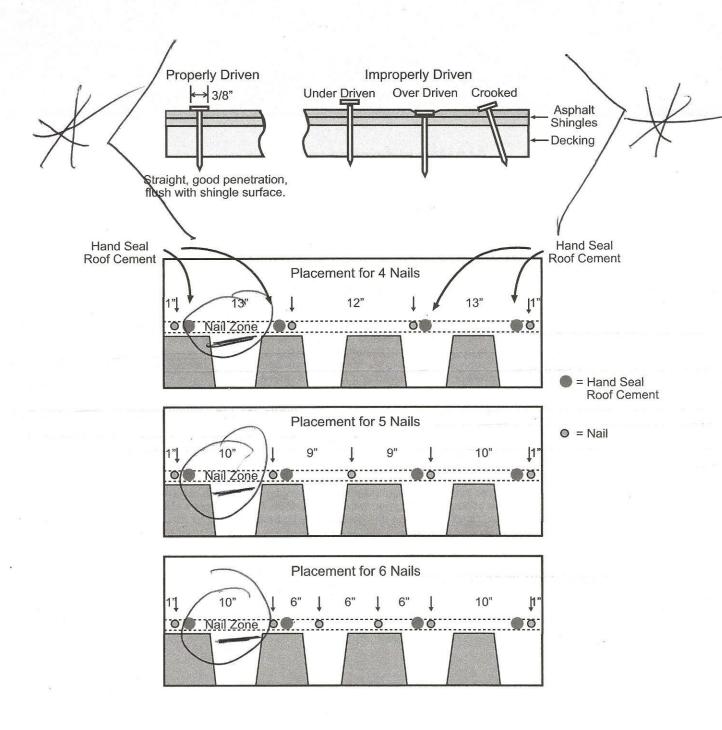
Nails must be driven flush with the shingle surface. Do not under drive or over drive the nails. Under driven nails may damage the overlaying shingle by tearing through that shingle as it settles down over the nail's head or if stepped upon. An under driven nail may hold the overlaying shingle up, providing an opportunity for wind damage. An over driven nail will tear through the shingle, allowing a path for water intrusion and reducing the shingle's resistance to wind damage. A nail that is driven at an angle may cause any or all of the problems from under driven and from over driven nails.

Nails must be properly positioned on the shingle. See the figures on page 2. The nail zone is indicated by a pair of paint lines on the face of the shingle spaced about 1/2" apart, about 6" up from the bottom edge of the shingle. If nails are placed below the nail zone, the nail heads may not be covered by the overlaying shingles. If nails are placed above the nail zone, the wind resistance of the shingles is reduced and damage may occur which allows an extra path for water intrusion. The indicated positions across the shingle are to assure the nails are not near the end-to-end joints of the overlaying shingles.
