ISSUE 122: DECEMBER 2016

# DIESEL TORQUE

# Muted Mondeo

# Hi H1

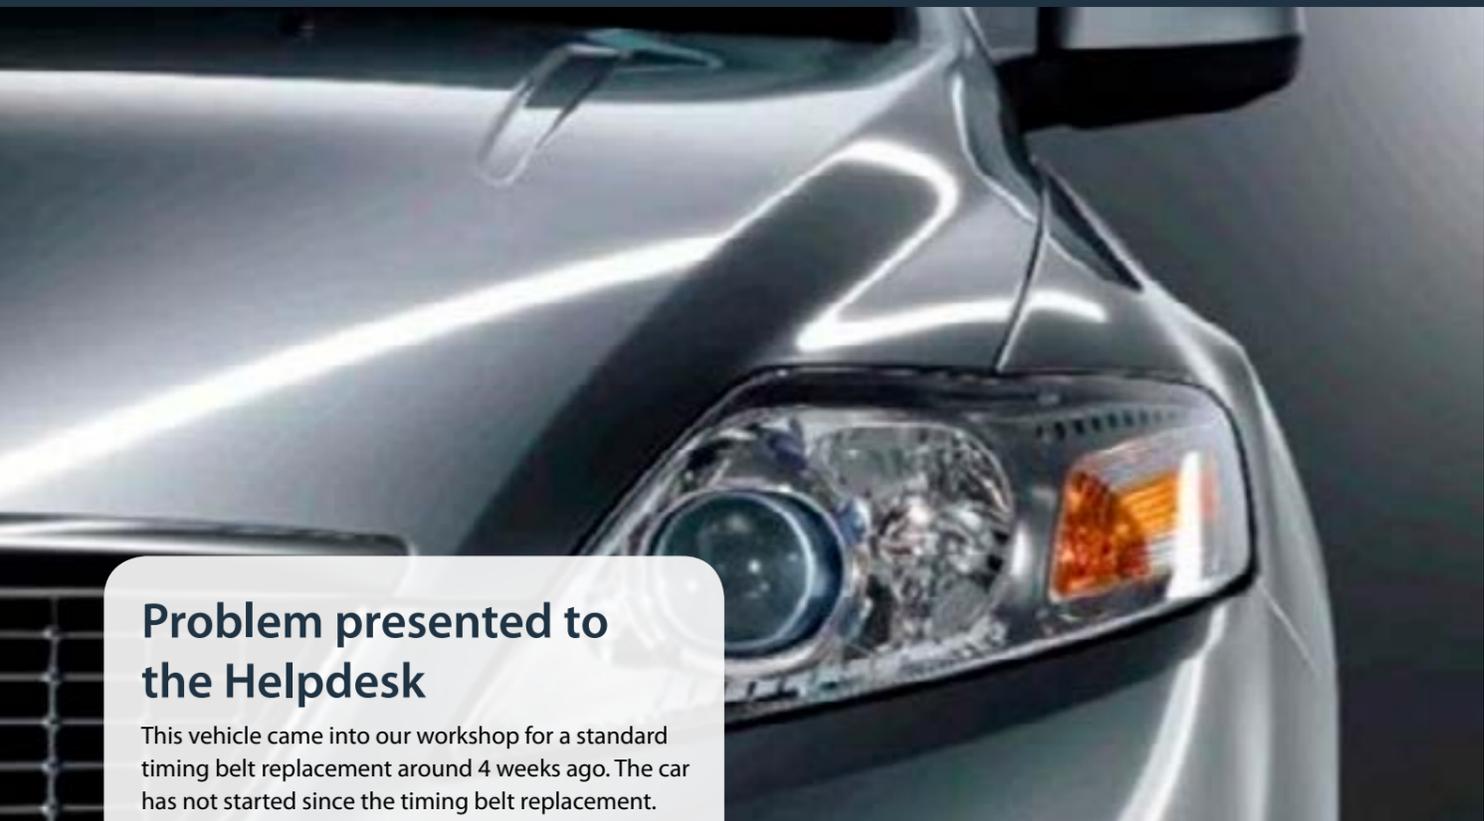
This vehicle came into our workshop for a standard timing belt replacement around 4 weeks ago. The car has not started since the timing belt replacement. There are no fault codes in any of the ECU's in the vehicle. We scoped several signals with our own scope (not an ATS scope) and can only see that the piezo injector pattern looks different on this car than on an identical car which goes fine.

We have replaced the crank and cam sensors, in case we damaged them. We have even tried a second hand ECU, but that stopped the vehicle from being wound over with the starter motor as that ECU was not programmed into the vehicle.

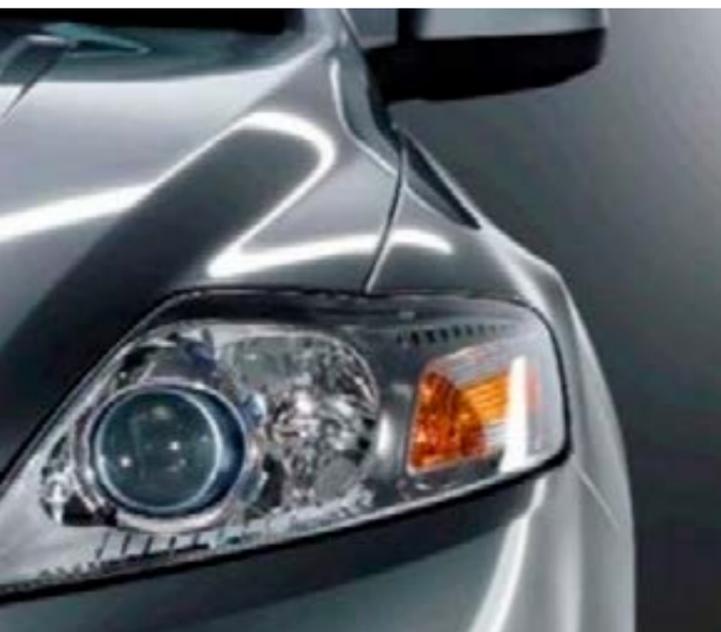
The phase difference is a bit more than 3 teeth on the tone wheel. On the circumference of the tone wheel are 58 teeth and 2 missing teeth. This makes that from teeth to teeth the crank shaft has rotated 6 degrees. In crank angle degrees is 3 teeth 18 degrees. That is equal to one having the timing belt on the crank shaft sprocket 1 tooth out.

This job ended up being very expensive as a result of the same mistake made by three technicians. I have not read the workshop manual, but the manual which was used clearly leaves room for error.

The timing belt was redone and the car started perfectly (after connecting the injectors correctly back up again).

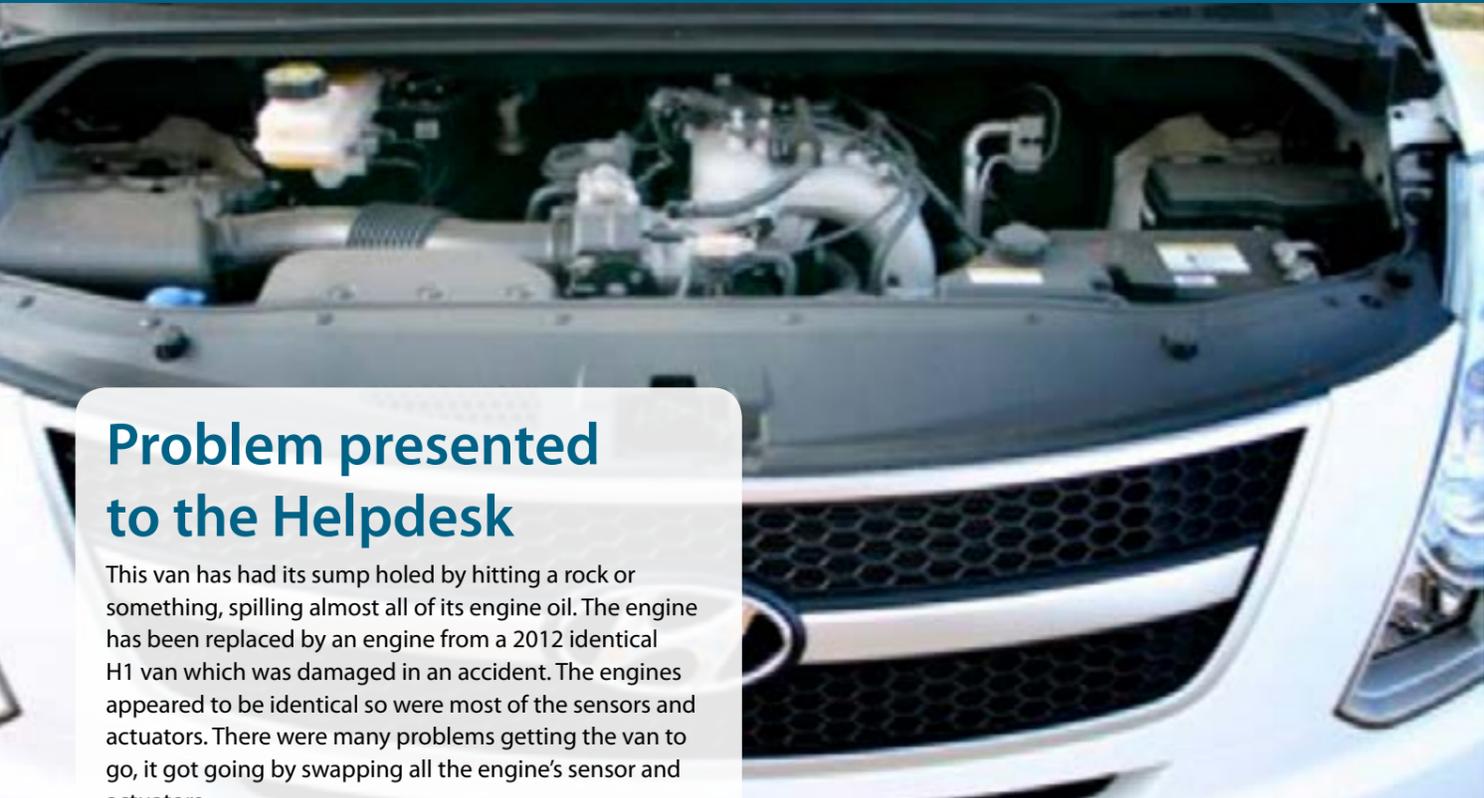
This van has had its sump holed by hitting a rock or something, spilling almost all of its engine oil. The engine has been replaced by an engine from a 2012 identical H1 van which was damaged in an accident. The engines appeared to be identical so were most of the sensors and actuators. There were many problems getting the van to go, it got going by swapping all the engine's sensor and actuators.

The old PDV was taken apart and some dirt was found in the valve. The ball bearing needs to seal properly when the magnetic field of the solenoid pushes onto the ball. In this case a tiny bit of grit kept the valve open on a small leak, increasing the square surface area of the valve where the hydraulic rail pressure acted upon. An increase in pressure created a strong enough force to open the ball bearing valve in against the electromagnetic force the solenoid valve needle put on the ball bearing.

During our DMS 1-3 common rail Diesel training we advise to fit to any common rail Diesel vehicle (also brand new ones) an extra filter unit with water separation bowl. If water enters the fuel system, the pump, valves and injectors need to be replaced. The genuine filters used on many modern vehicles are not having enough water separation area, plus the water sensor with electrodes protruding into the filter react often too late. It is incredibly expensive to replace the damaged items. It will always end up in a battle with your customer, as water damage to these components is not covered by any warranty and fuel companies do not like to admit that the water came from their fuel station (prove it...).
