1816 FARMINGTON QUAKER MEETINGHOUSE

EXTERIOR RESTORATION

CONSTRUCTION DOCUMENTS

ARCHITECT'S PROJECT NO: 2022.23C DATE: OCTOBER 23, 2023

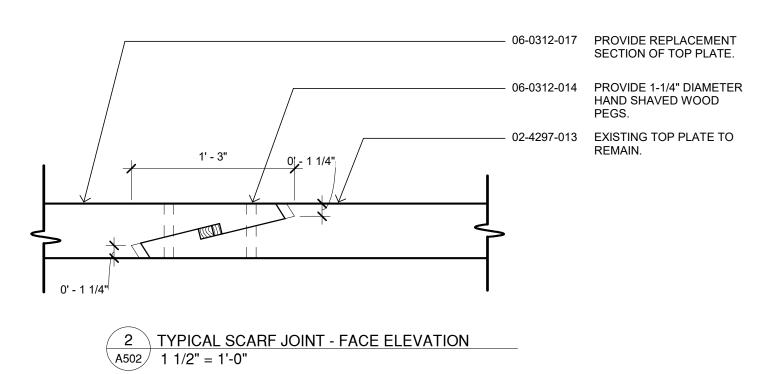
- REPLACEMENT WOOD SECTION. - EXISTING WOOD. — DRILLED INJECTION PORTS FOR EPOXY (TYP.) TWO (2) NAILS OR SCREWS.
 INSTALLED AT TOP SIDE OF MEMBER
 TO HOLD PIECES TOGETHER AT BOTH
 ENDS OF SCARF JOINTS WHILE EPOXY
 CURES. (TYP.) - MAINTAIN GIVEN SLOPE FOR SCARF JOINT. 1 TYPICAL SCARF JOINT - SIDE ELEVATION 1 1/2" = 1'-0"
