ISSUE 123: JULY 2017

DIESEL TORQUE

OFFICIAL MAGAZINE OF THE ASSOCIATION OF AUSTRALASIAN DIESEL SPECIALISTS INC. (AADS)

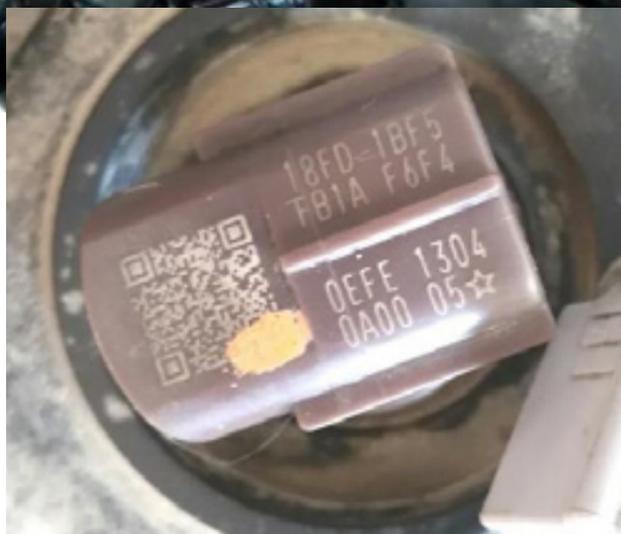
Denso CR injector and its 30-digit code.

For example, some Denso injectors use 30-digit Hex codes. When replacing the injector, this code MUST be entered into the vehicles ECU so that the necessary adjustments to activation timing, duration of injection and rail pressure can be made by the vehicles' ECU during operation and remember, the vehicle has to be able to do this under a multitude of circumstances and driving conditions.

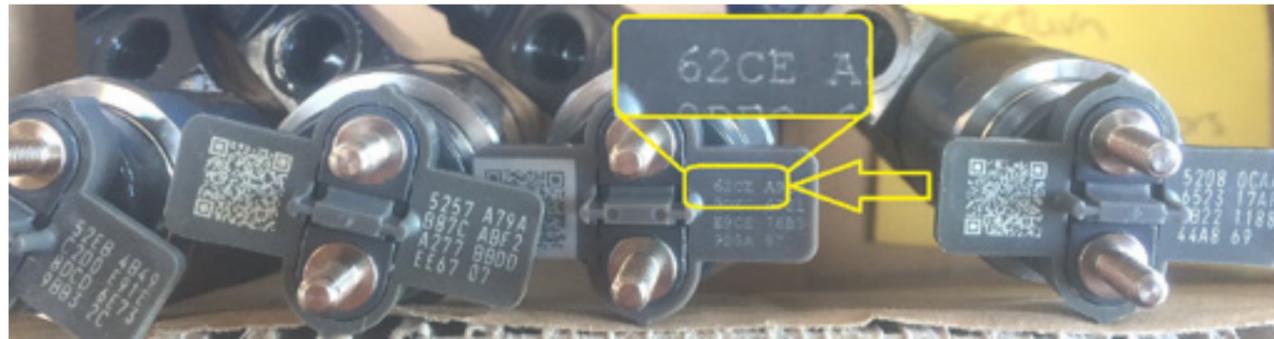
An injector clearly showing the wrong code but supplied as part of a "Set".

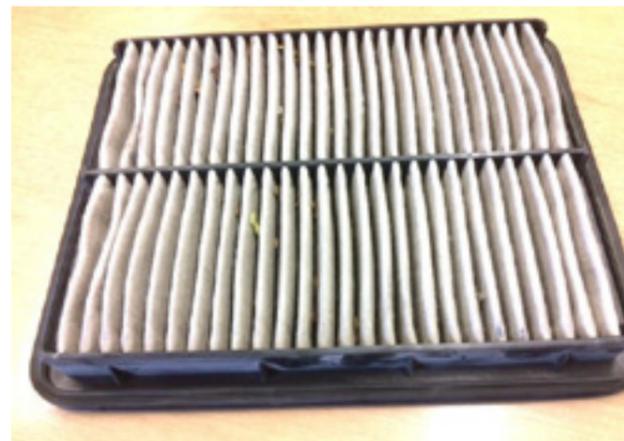
Aftermarket airfilter

While the diagnostician was checking the MAP and MAF he removed the air cleaner top, and found an aftermarket air filter.
